**RE: AS-BUILT REPORT FOR 2007 PERMIT #'S: 39500-FP (DSL), NWP-2007-955-/1 (USACE)**

Enclosed is the As-Built Report for the Sutherlin Land LLC Commercial Development & Wetland Compensatory Mitigation Project in Sutherlin and Oakland, Douglas County, Oregon (25S-5W-19B, Tax Lot1600 and 25S-6W Tax Lot 100).

enclosure:  
As-Built Report for Permit #39500-FP, NWP-2007-955-/1

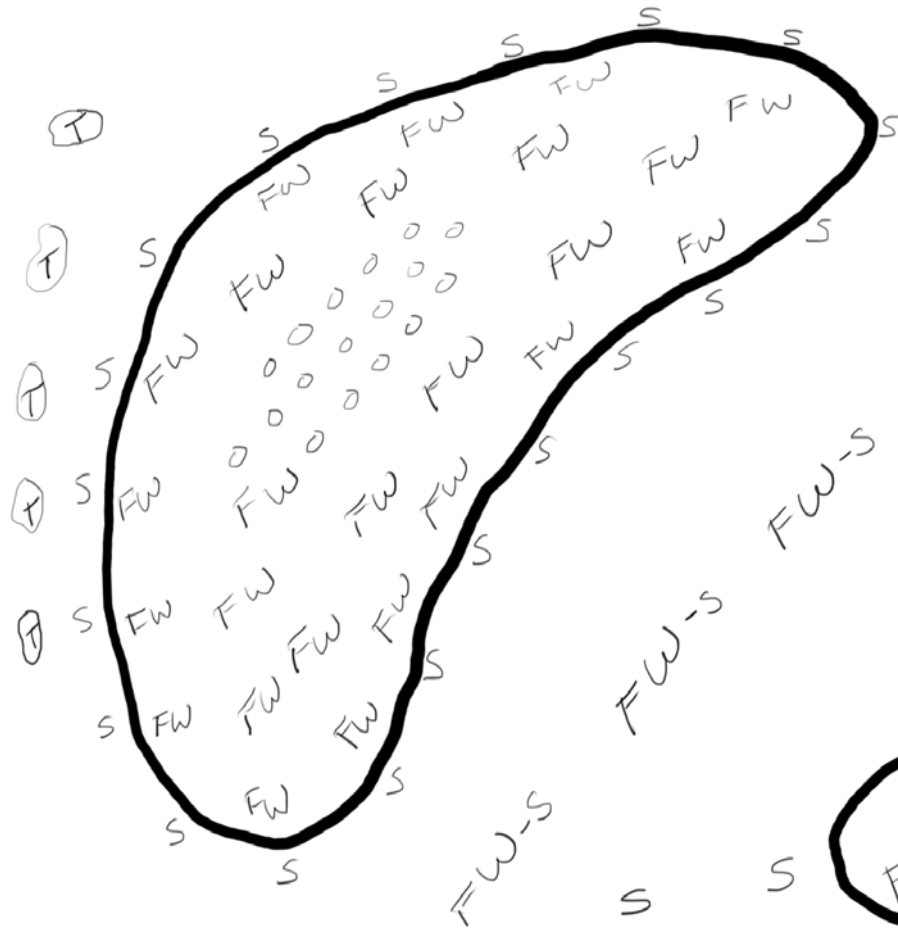
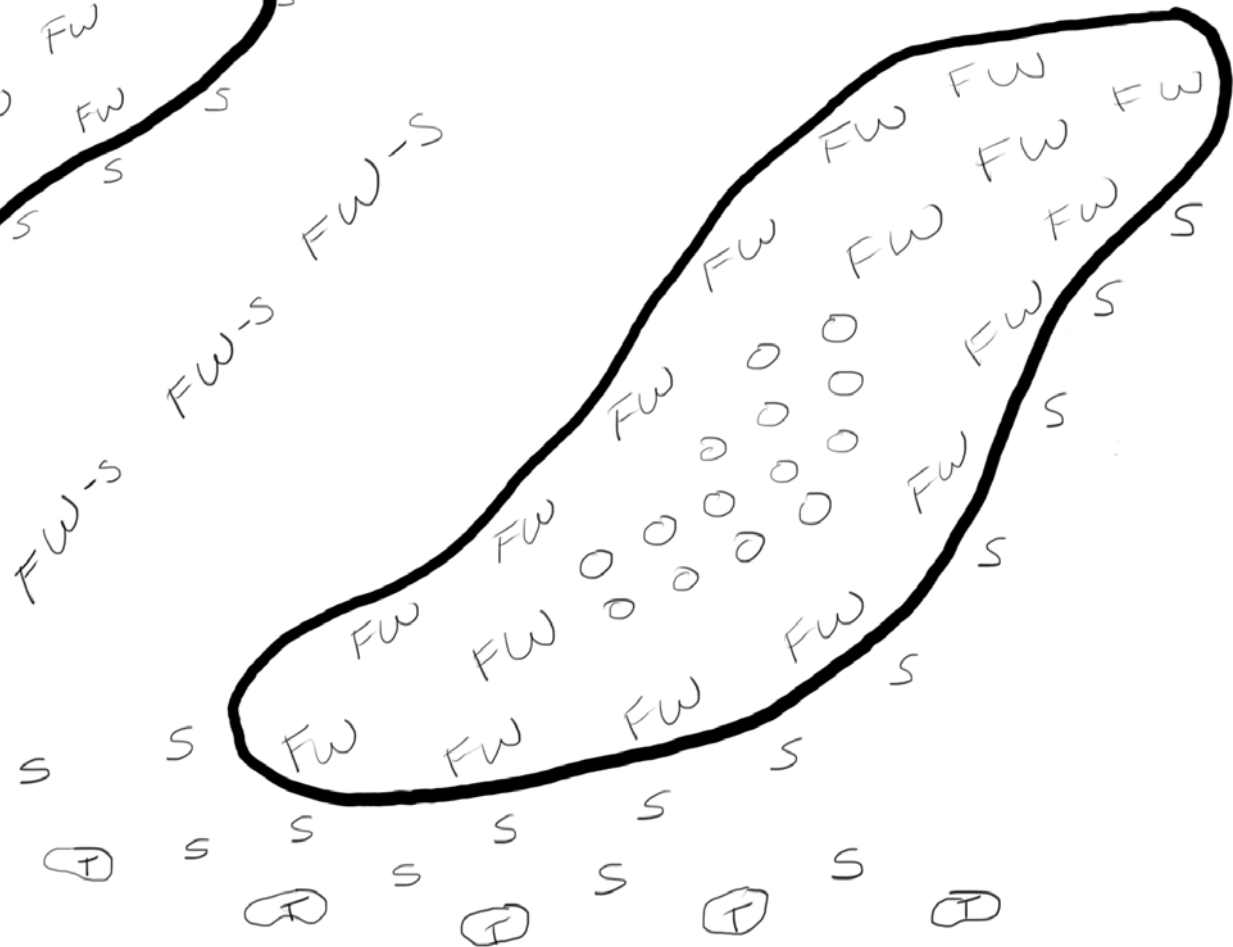
## Planting Plan for Depressions 1 & 2

DEPRESSION 1

DEPRESSION 2

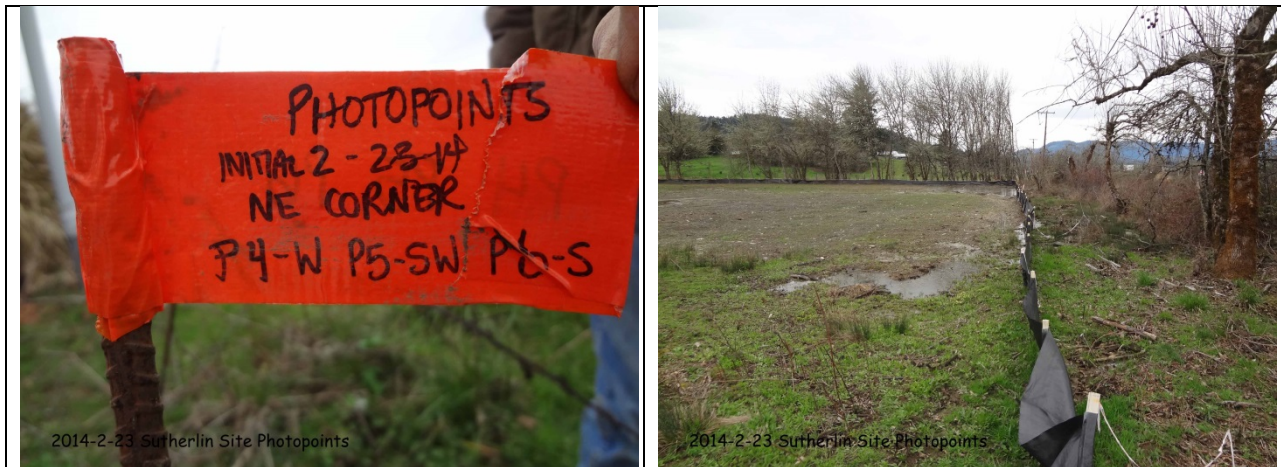
Photo points 4-6: Taken from Northeast corner of fill material on tax lot 1600, near property line:  
4-West View, 5-Southwest View, 6-South View

2014-2-23 Sutherlin Site PP-4W

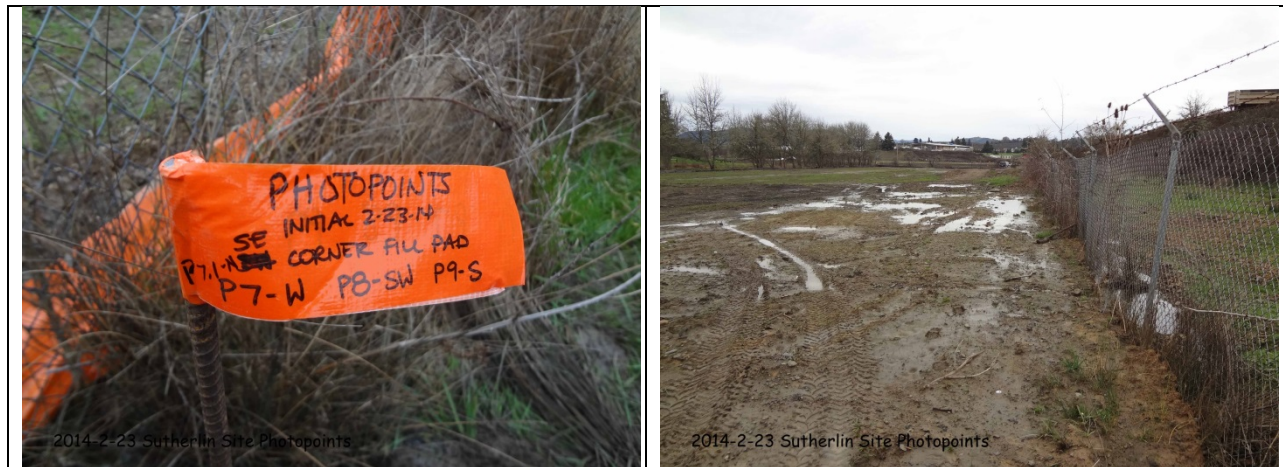
Photo points 7-9: Taken from Southeast corner of the fill material on tax lot 1600, at the fence line:  
7.1-North View, 7-West View, 8-Southwest View,  
9-South View

2014-2-23 Sutherlin Site PP-7.1N

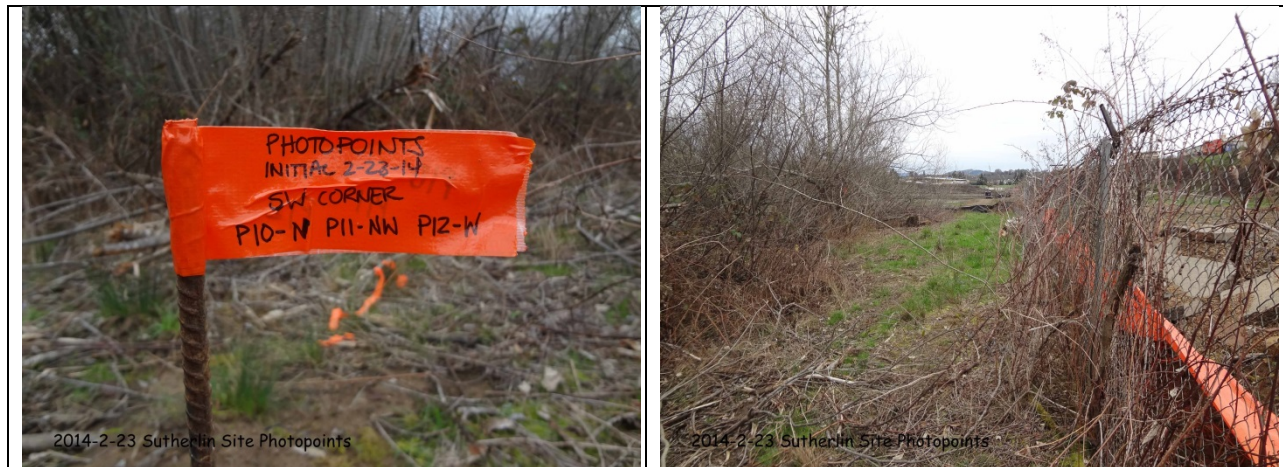
Photo points 10-12: Taken from Southeast corner of tax lot 1600, at the fence line:  
10-North View, 11-Northwest View, 12-West View

2014-2-23 Sutherlin Site PP-10N

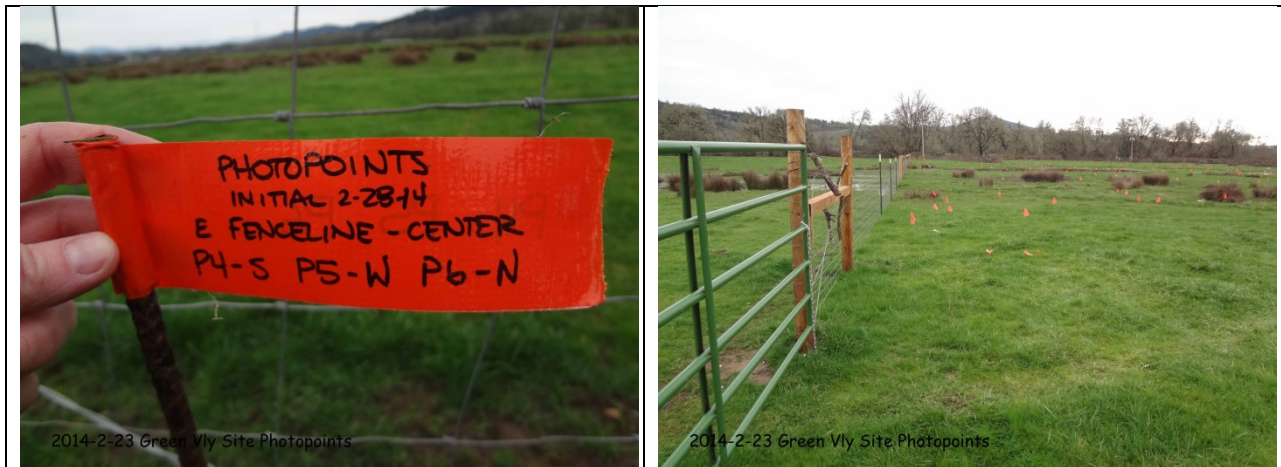
Photo points 4-6: Taken from middle of the East fence line of the Mitigation Site:  
4-South View, 5-West View, 6-North View

2014-2-23 GreenVly PP-4S

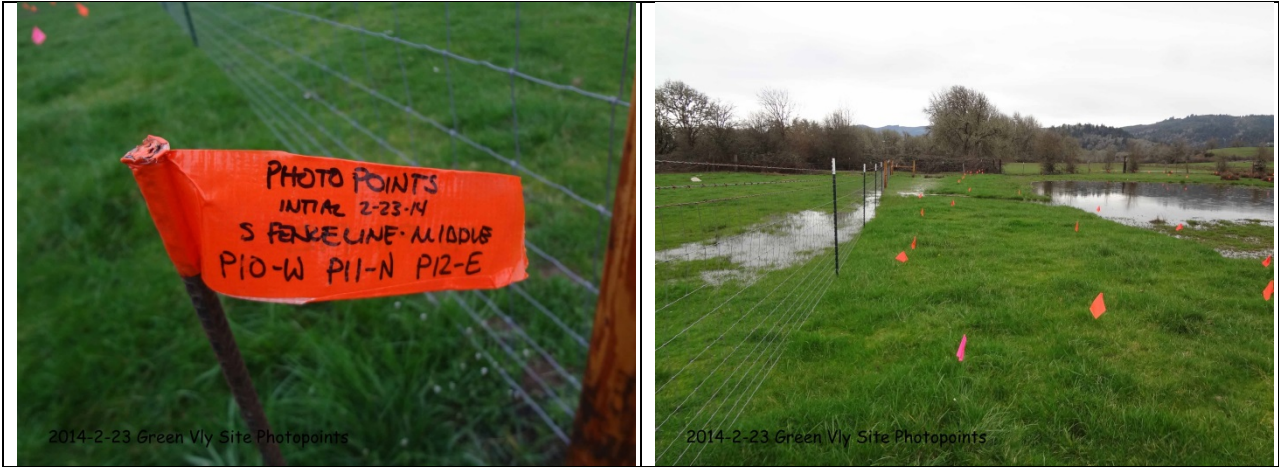
Photo points 10-12: Taken from middle of the South fence line of the Mitigation Site:  
10-West View, 11-North View, 12-East View

2014-2-23 GreenVly PP-10W

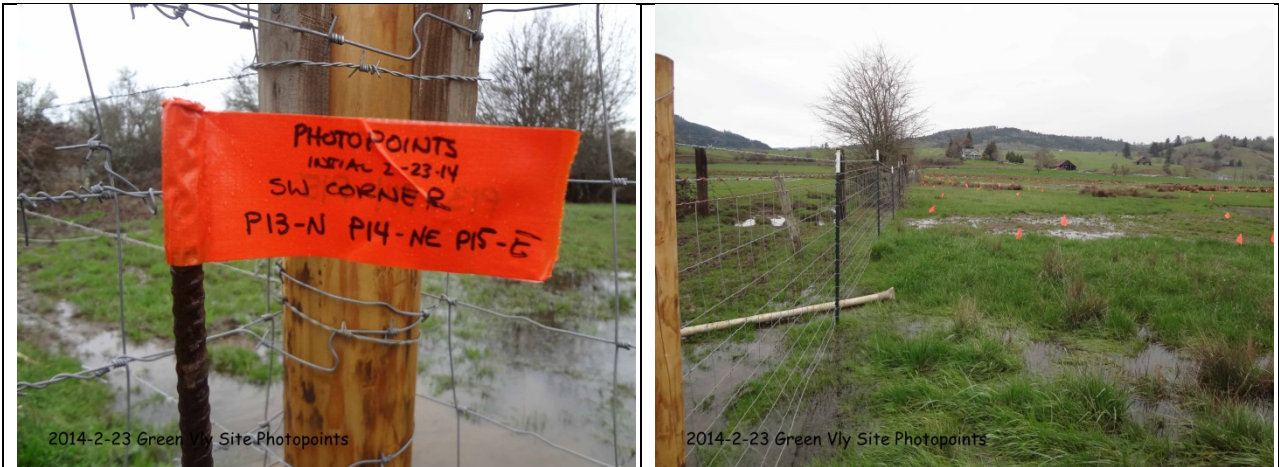
Photo points 13-15: Taken from Southwest corner of the Mitigation Site, at the fence line:  
13-North View, 14-Northeast View, 15-East View

2014-2-23 GreenVly PP-13N

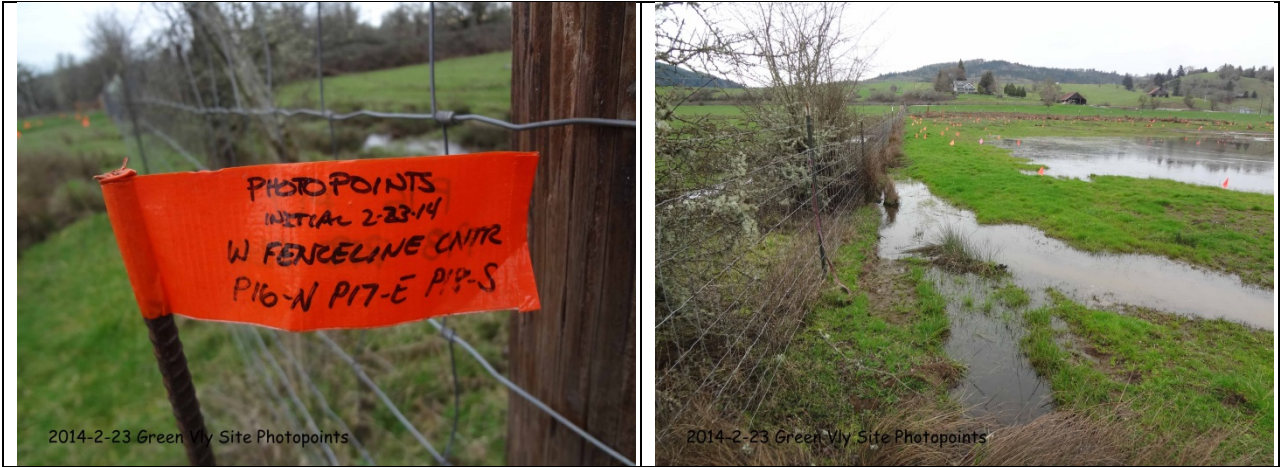
Photo points 16-18: Taken from middle of the West fence line of the Mitigation Site:  
16-North View, 17-East View, 18-South View

2014-2-23 GreenVly PP-16N

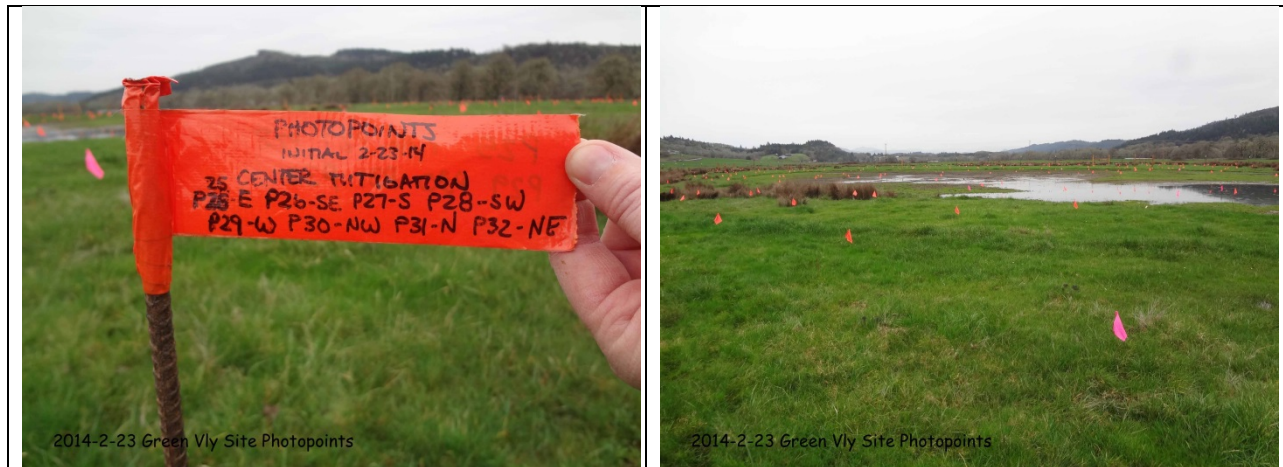
Photo points 25-32: Taken from middle of the Mitigation Site in all directions:  
25-East View, 26-Southeast View, 27-South View,  
28-Southwest View, 29-West View, 30-Northwest  
View, 31-North View, 32-Northeast View

2014-2-23 GreenVly PP-25E

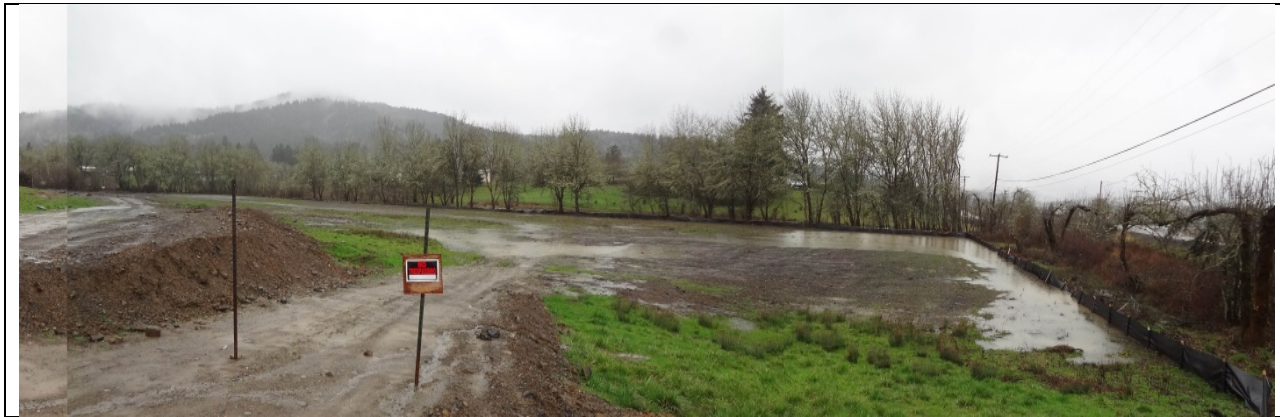
2014-2-14 2014-2-14 Sutherlin-HighH2O (1-3) Panoramic  
Effects of High Rain Event, NE corner to SW view

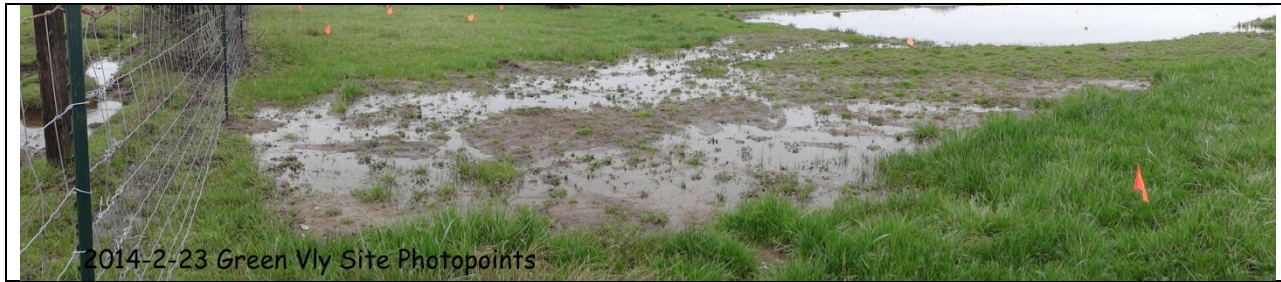
2014-2-23 GreenVly PP-SW LowPt\_PAN  
CWM low point in SW corner of project site that needs to be addressed, summer 2014 to help keep water into the northern most depression.
